**SUPPLEMENTAL CONDITION ASSESSMENT
AND
RECOMMENDATIONS**

WILLIAM WARD HOUSE

**Georgetown vicinity,
Sussex County, Delaware**

**January 10, 1997
(Draft Submission)**

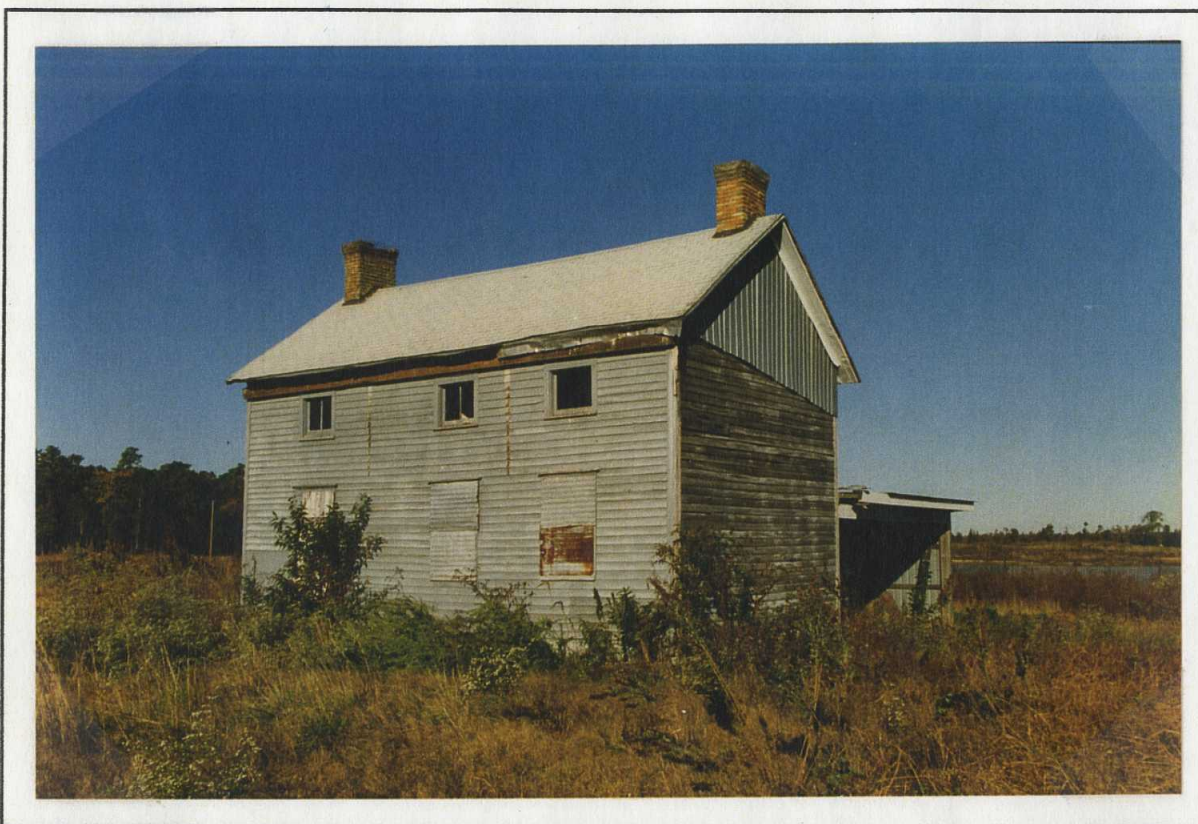
Photo 1; South (front) elevation and partial east elevation (see Photo Nos. 1 & 5, 1992). The metal siding at the top of the east gable end was above the roof of the previously attached shed addition (see Photo No. 2, 1992). Note that the south elevation siding received paint more recently than the east.

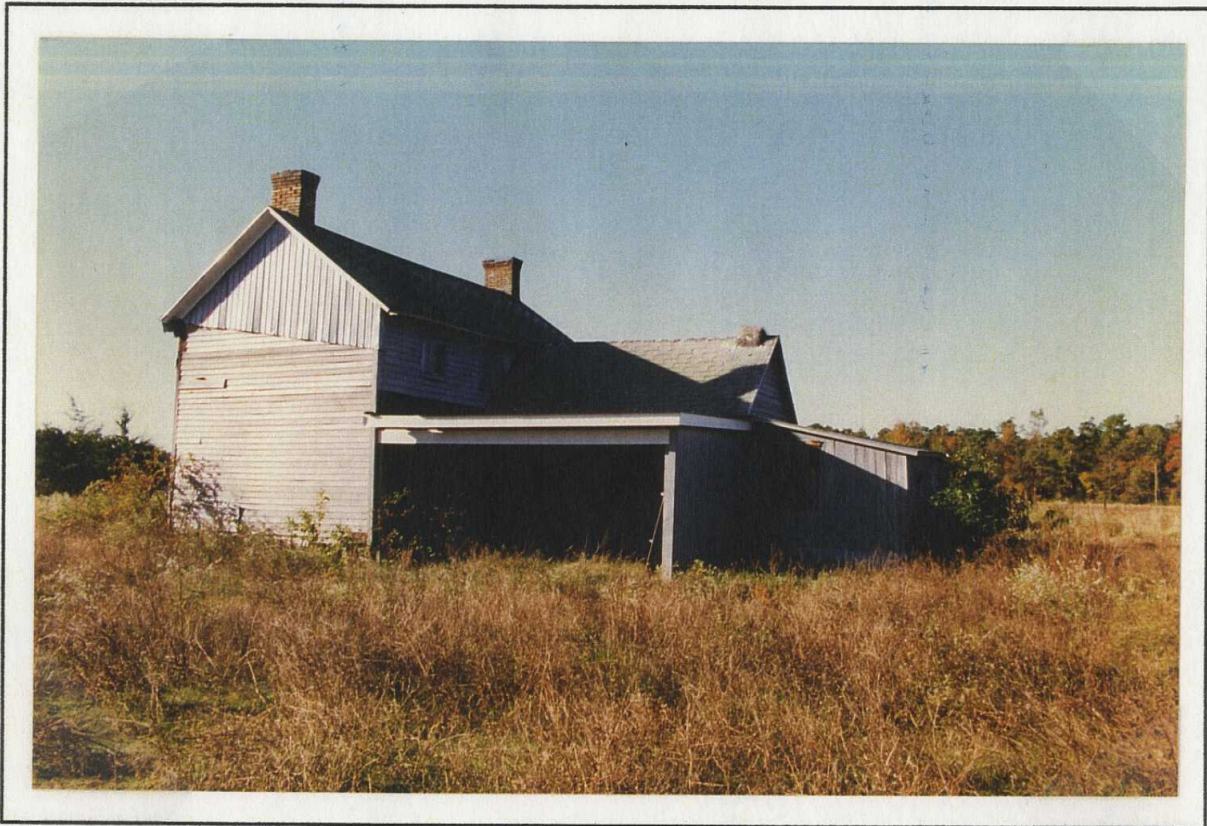
Photo 2; East elevation and partial north elevation, showing one of the previous Butler-type additions which was not removed (see Photo No. 2, 1992). The reuse scheme calls for the lean-to addition on the far north end to be removed. Note the collapsed chimney on the north end of the addition.

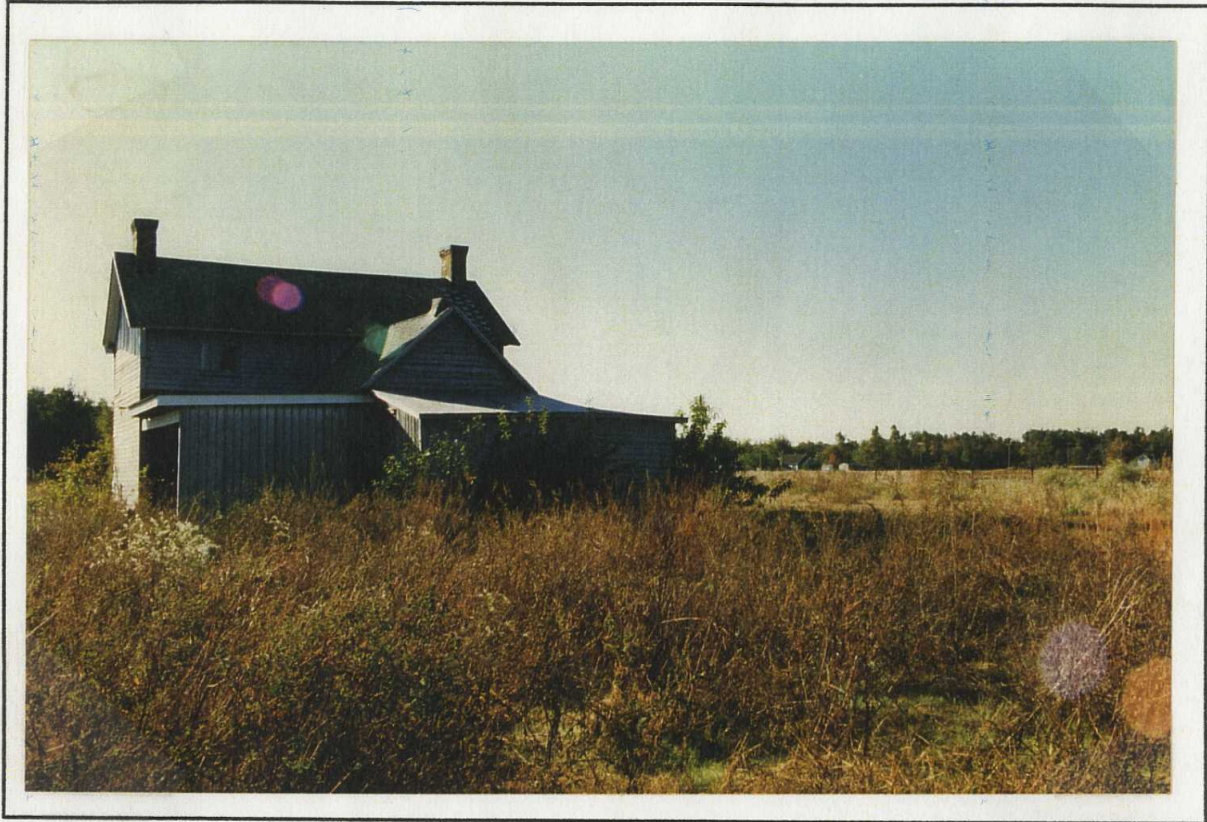
Photo 4; North elevation, showing the three additions to be removed (see Photo No. 3, 1992).

- a. careful removal of the lean-to addition on the north side, the porch on the west side and the remaining Butler-type shed on the east
- b. installation of a shed roofed porch on the front (south) elevation and on the west elevation of the addition (kitchen)

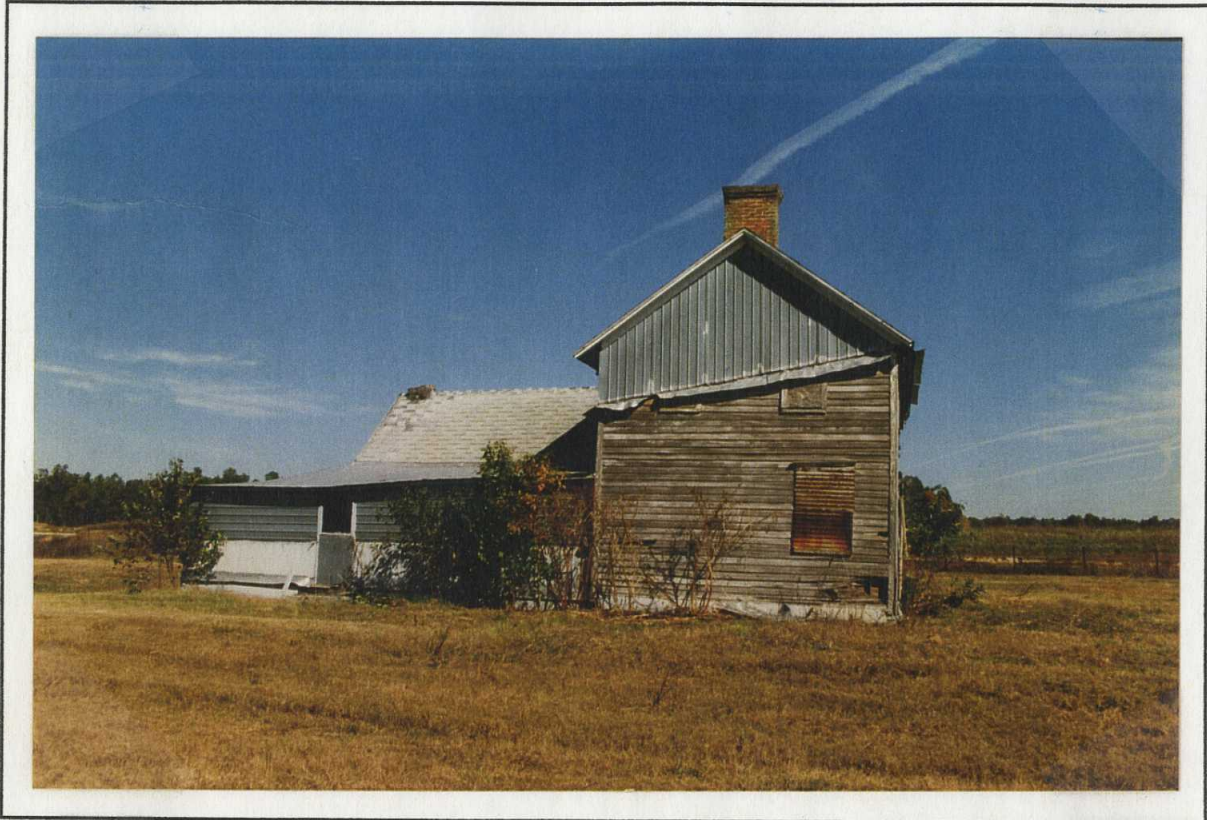
Photo 5; West elevation, showing the enclosed porch and the roof of the addition beyond (see Photo No. 4, 1992). Note the deteriorated siding at the lower southwest corner of the main building and the extent of modern material which still needs to be removed.

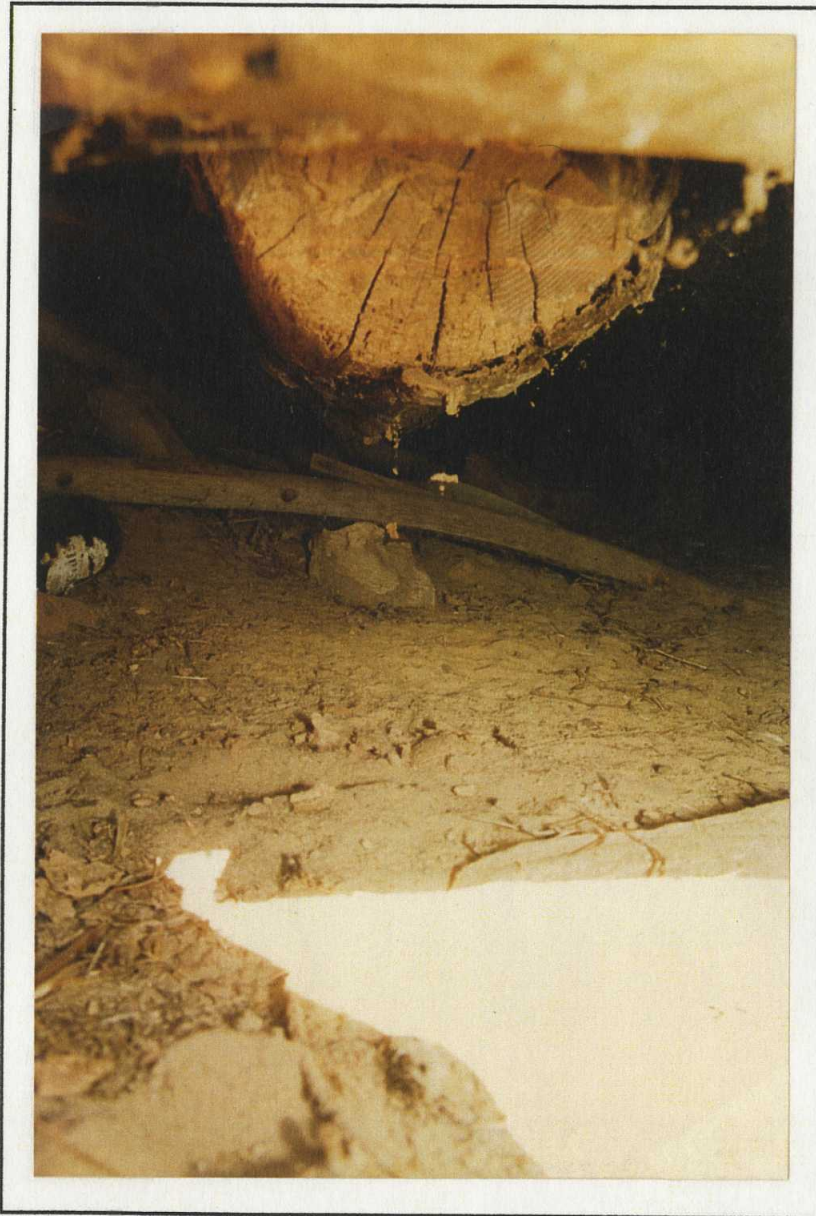
The second floor framing is being compromised at its bearing ends where the flooring and exterior wall have sustained heavy damage from water infiltration (the attic floor south windows have no coverage). The first floor log joists and the perimeter sill have been destroyed by termites. The infestation has been inactive for several years, however; massive termite tunnels are still visible spanning between the ground and bottom of the logs. Although the termites had begun to ingest the floor boards, the damage is not apparent from the top side and a majority of the boards remain in good condition. The damage to the sill and logs had been concealed by the metal skirt.

Photo 6; Detail of first floor log joist, showing the tenon pulling out of the sill as the log has sagged. Note that the log (about 8 inches in diameter) is only a few inches above grade.

- c. stabilize building and raise at first floor level, replace first floor framing and install new brick foundation with concrete footings
- d. installation of additional attic floor joists to bring the live load capacity up to a minimum of 30 lbs/sf as required for residential sleeping area

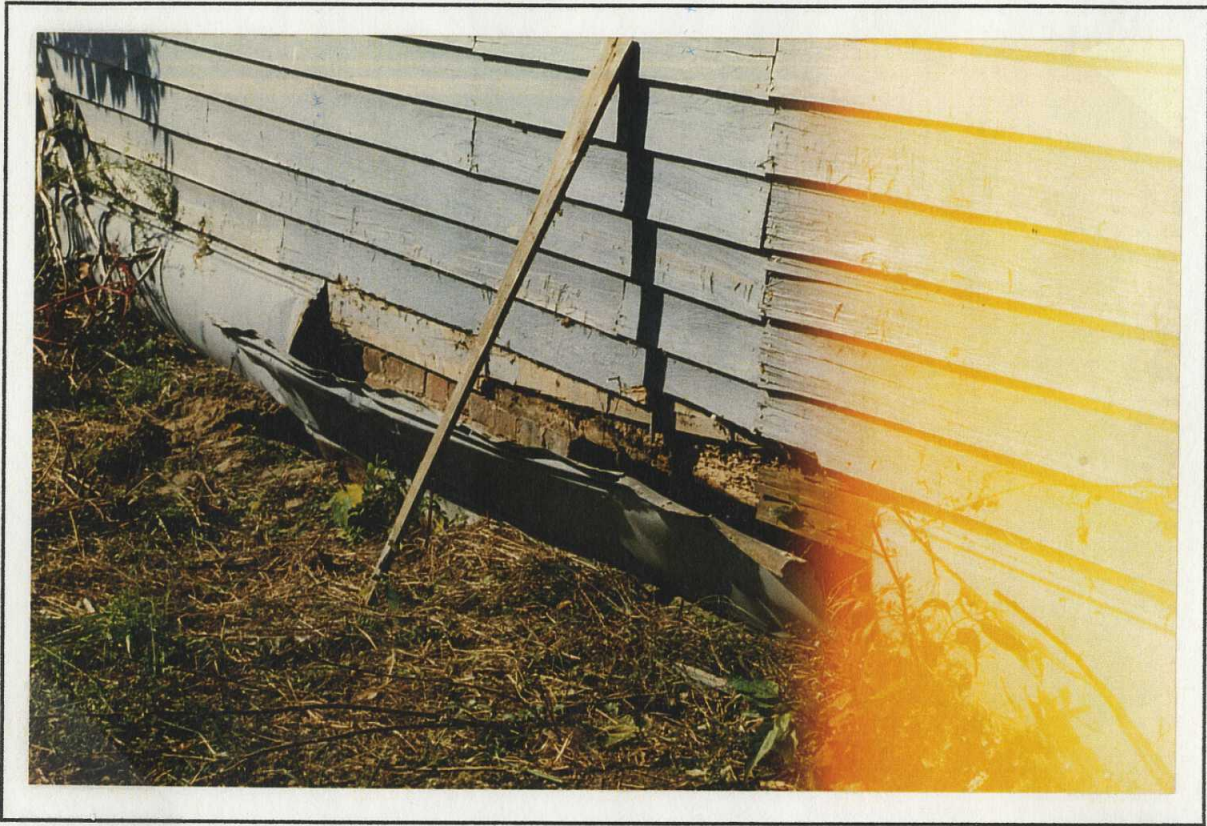
The foundation of the main building (see Photo No. 7) consists of individual 8" thick brick piers which are in poor condition. The piers extend only about 8" below grade and there are no footings. The foundation is concealed by a painted metal skirt which is tucked under

Photo 7; Detail of brick foundation pier and termite damaged sill. This area was opened along the south elevation near the eastern corner.

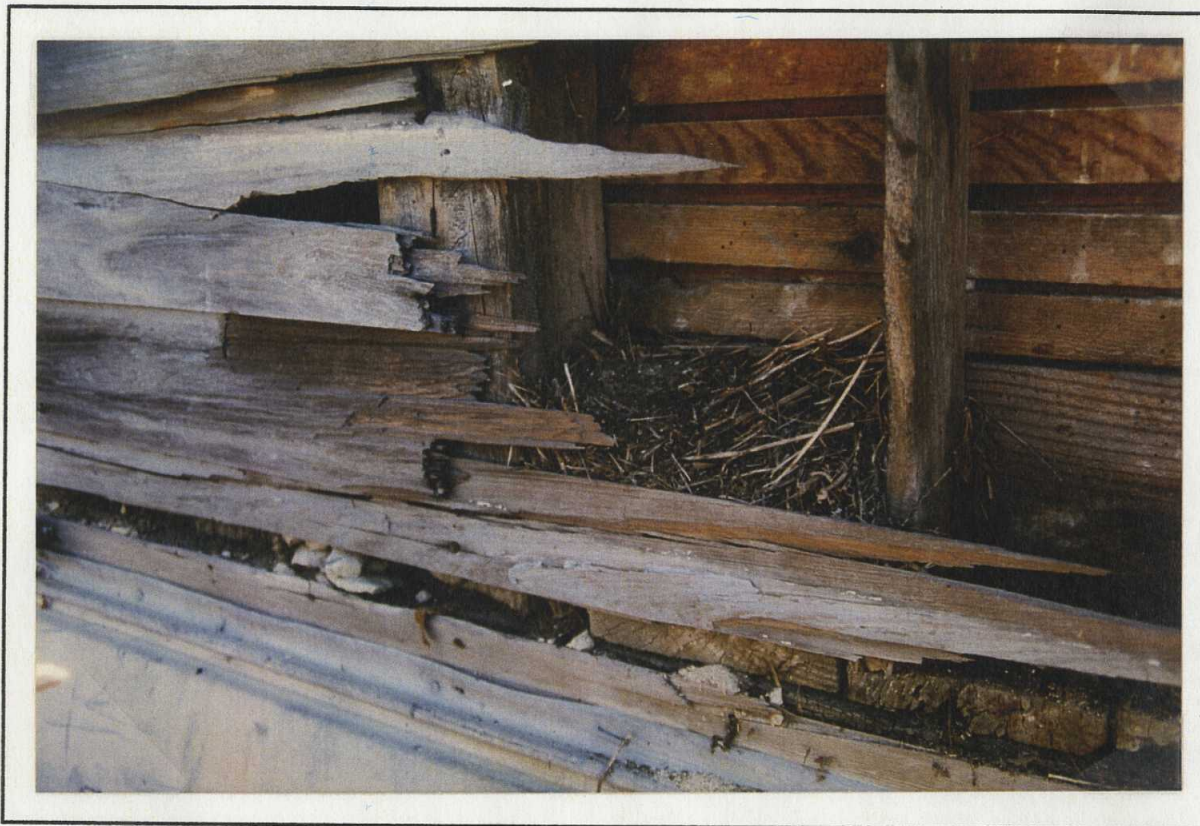
Photo 8; Detail of siding loss, west elevation near lower southern corner. Note that the post sits directly on the sill while the thin stud sits on plank flooring which comes out to the face of the sill.

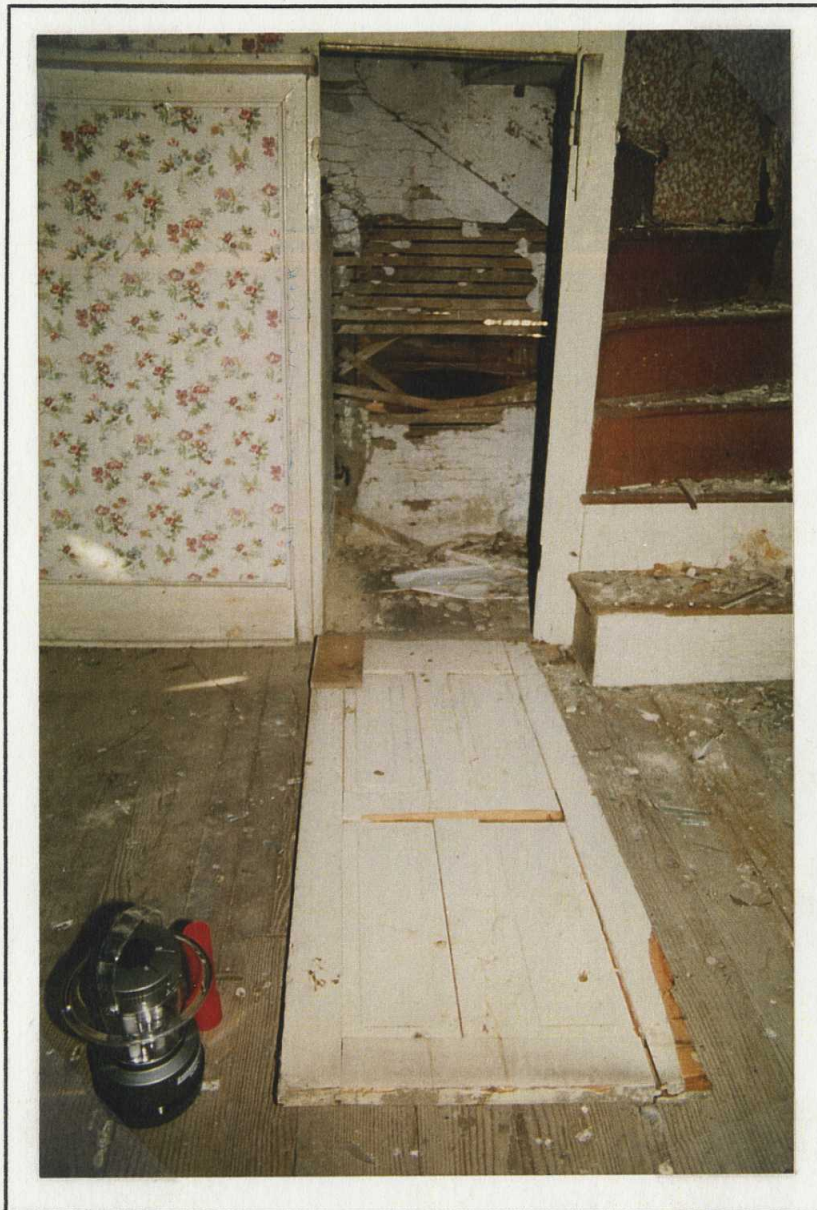
The only stair is a steep winder, located in the extreme northwestern corner of the main building (see Photo No. 9). From the hall closet, under the stair, one can see vivid circular saw marks on the stair's single-board stringer, treads and risers. The stair stringer is nailed to studs of west exterior wall. The railing at the top of the stair (see Photo No. 10) consists of three vertical posts (1 1/8" x 1 3/8") and an end post. The end post has a slight lamb's tongue on the outside corners. The verticals sit on a base rail, with quarter-round toe trim, which matches the height of the adjacent wall base. The top rail is a flat board with beveled edges and quarter-round molding which has been applied below the bevel.

Photo 9; Detail of first floor hall, showing mantel, closet and winder stair up to attic (see Photo No. 6, 1992). Note that the closet door has been ripped from its hinges and that daylight is visible through the lath in the closet.

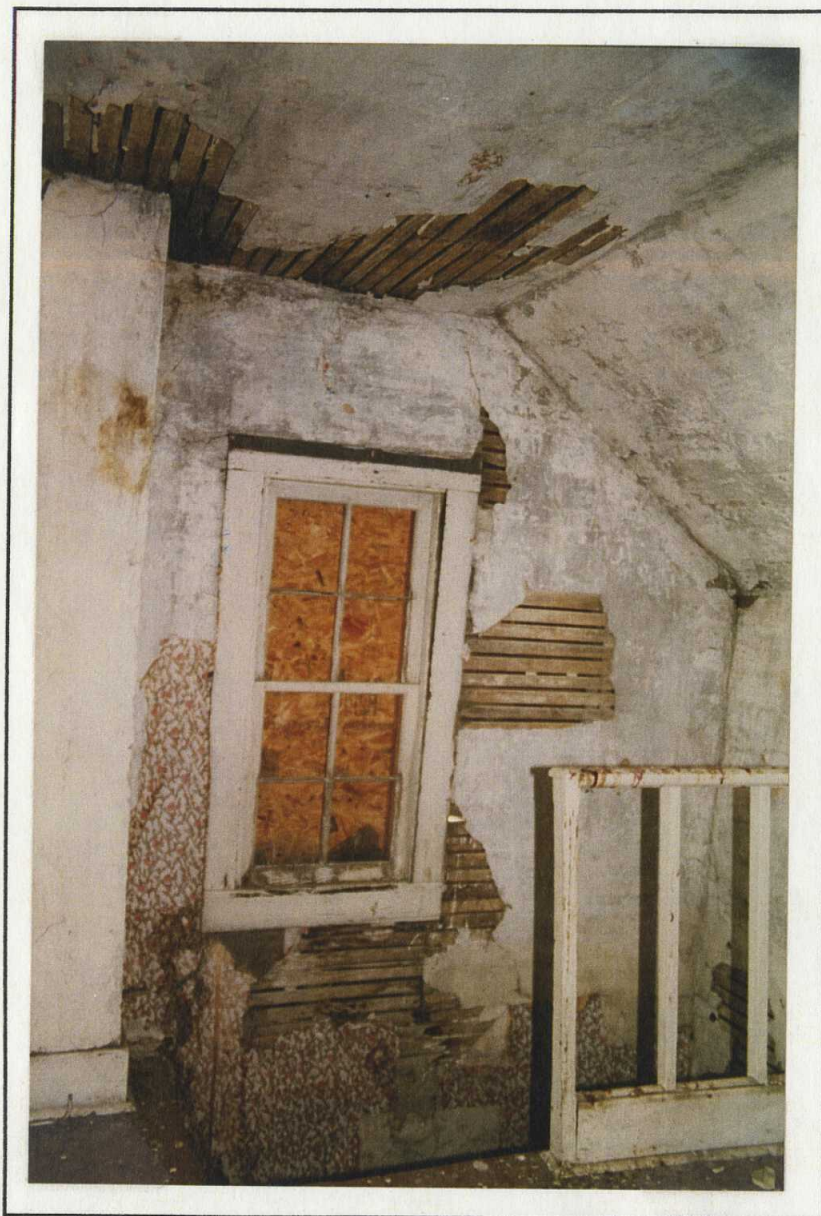
Photo 10; Detail of attic (west room), showing top of the winder stair. Note the plaster loss, lack of glazing in window, and bird droppings.

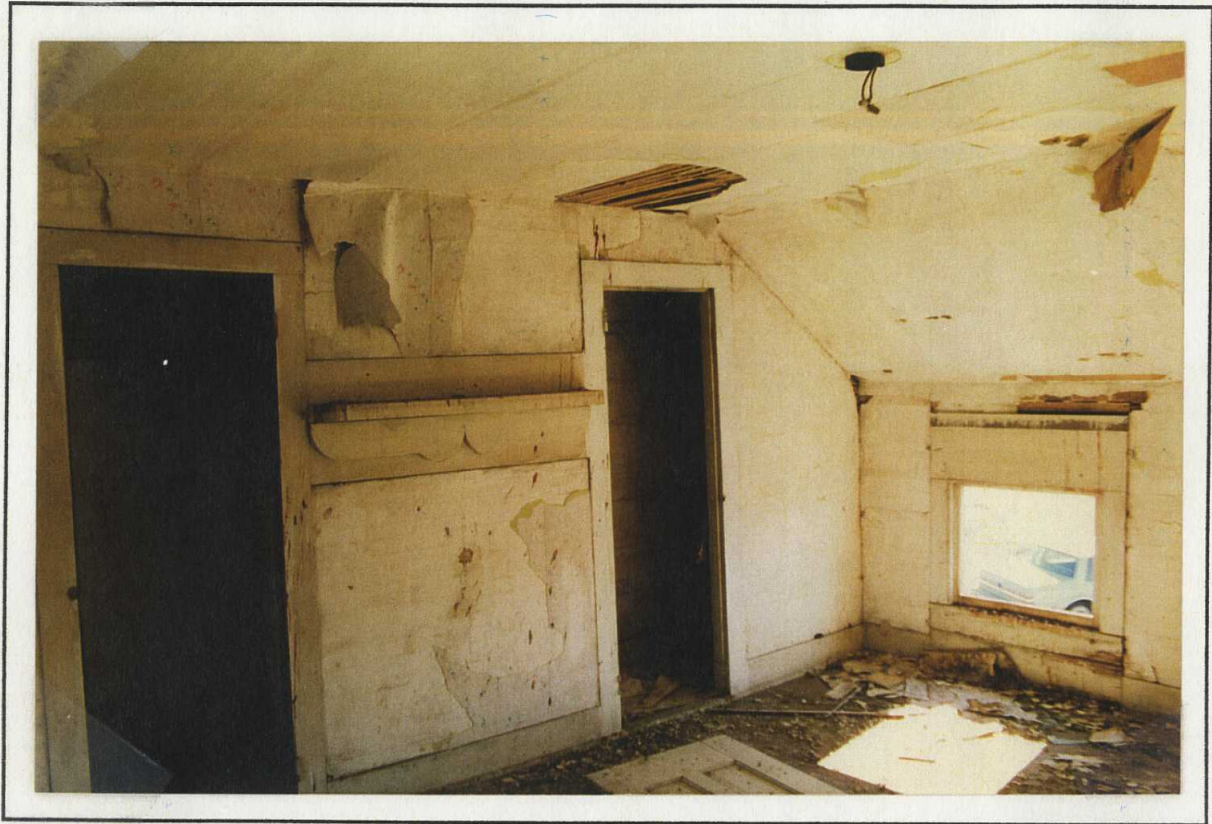
The attic east room mantel shelf (see Photo No. 11) is a full 2" thick and 6" deep, with rounded-notch corners. It spans between the jamb faces of the closets located on either side. The mantel shelf is mounted to a 15 1/2" high wood panel which is flush with the adjacent jambs and features a scalloped apron.

Photo 11; Detail of attic east room (looking southeast). Note that the exterior window sash is missing and that both closet panel doors have been pulled down.

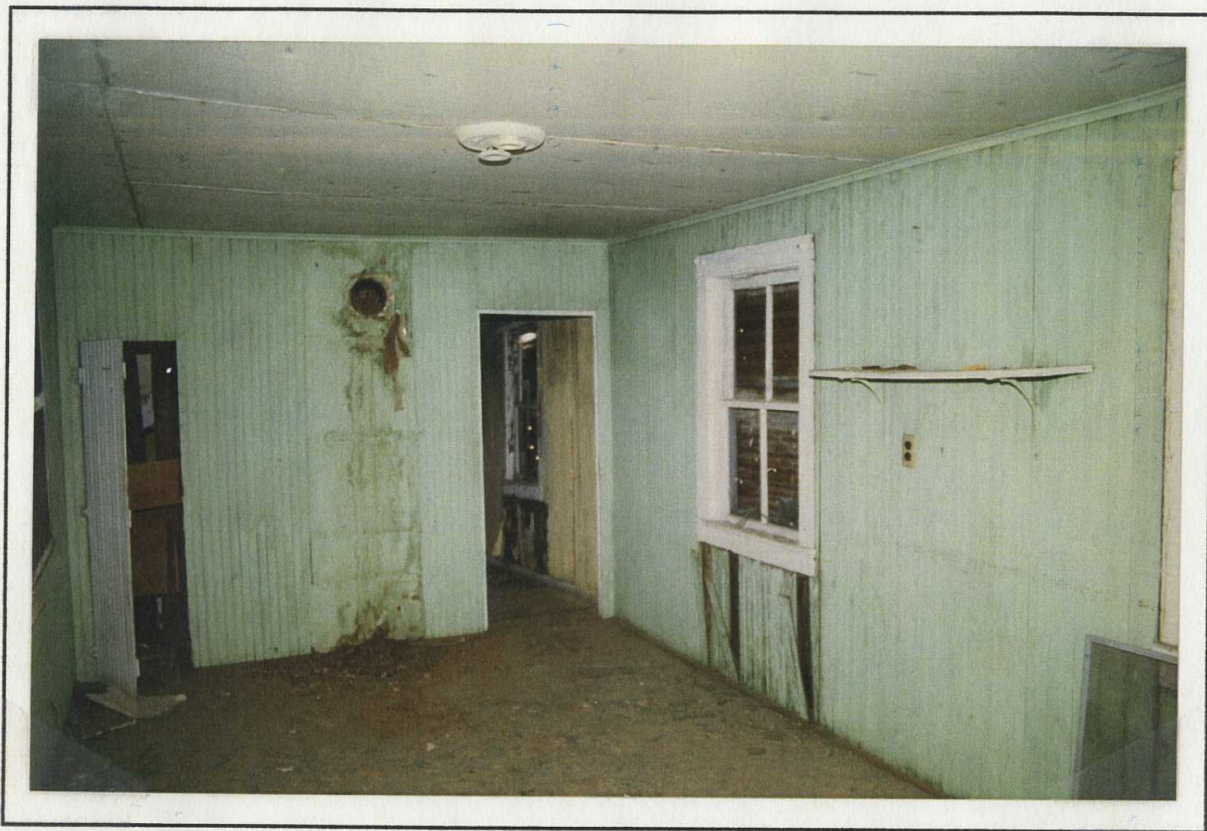
Photo 12; Detail of first floor of addition (looking northeast). Note damage to vertical bead board under exterior windows. Daylight is visible through the rusted metal panels nailed over the window openings.
